REPORT NO. NADC-84039-60

**CAUSES AND PREVENTION OF STRUCTURAL
MATERIALS FAILURES IN NAVAL ENVIRONMENTS**

PAPER NUMBER 115

CORROSION/84

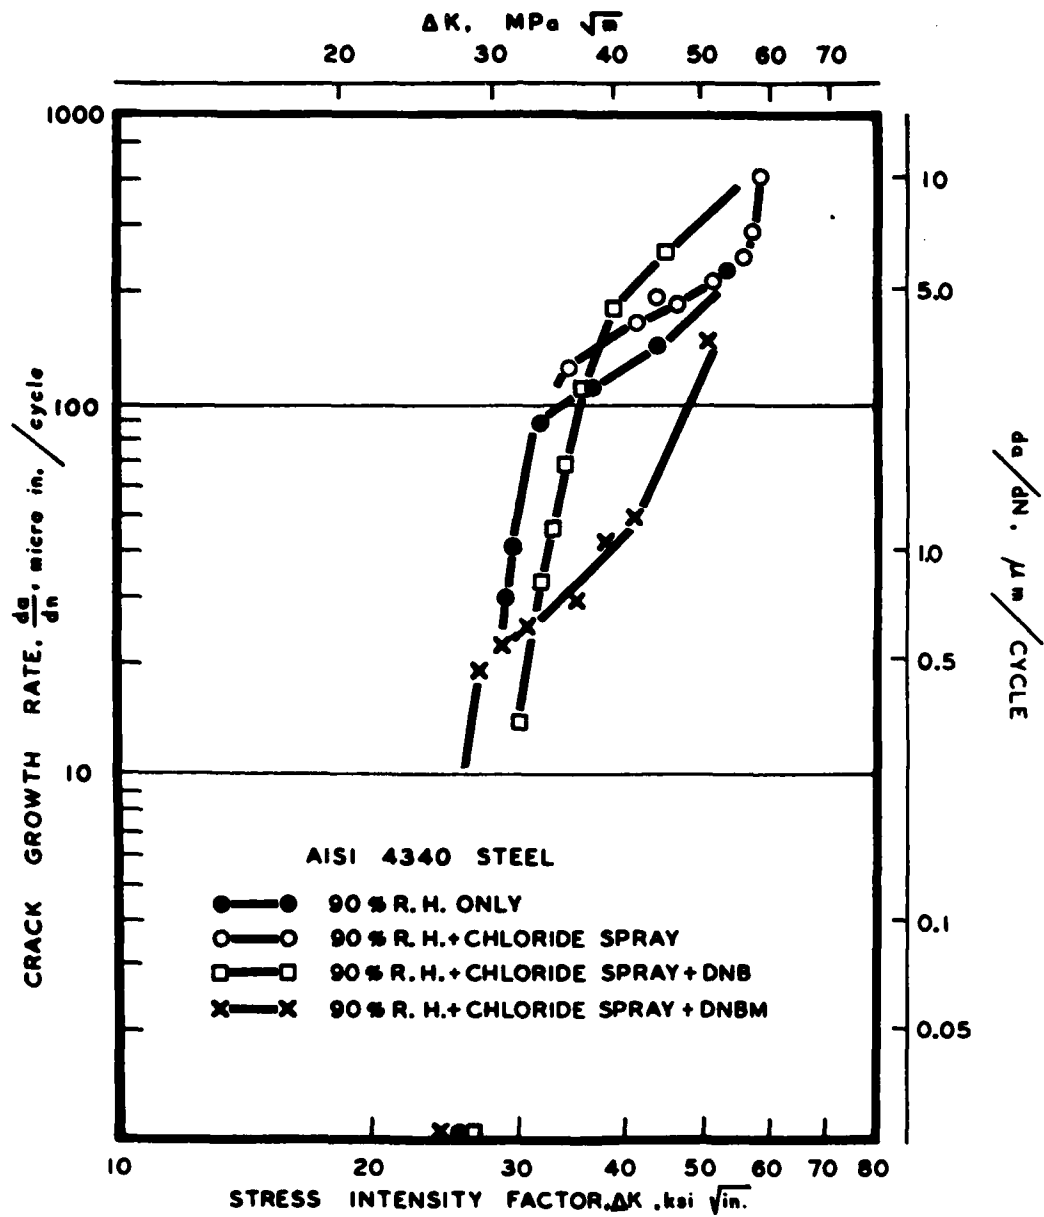
Figure 3. Crack growth rate - stress intensity relationship for 4340 steel during corrosion fatigue.

In the corrosion fatigue studies, ASTM method E-399 was used and the crack growth rate measured in crack extension per cycle (da/dN). The results, plotted as da/dN versus stress intensity factor (ΔK) for 4340 steel are shown in Figure 3. A comparative evaluation of the nature of the

curves show that the DNEM has the lowest crack growth rate at all stress intensities, and counteracted the effect of a chloride environment by a factor of approximately six in terms of fatigue life.

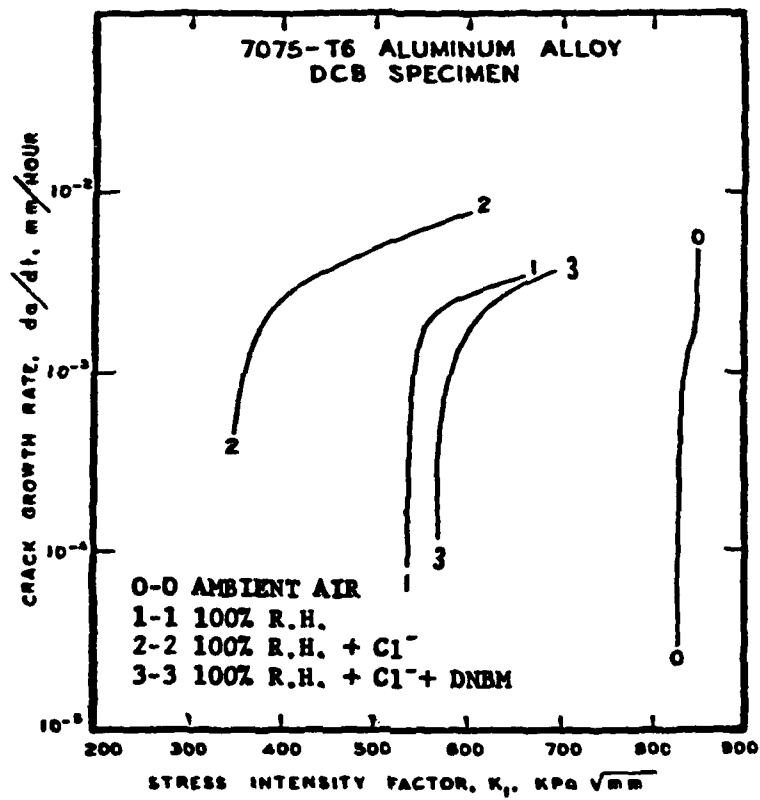
Figure 4. Crack growth rate - stress intensity relationship for 7075-T6 alloy during stress corrosion cracking.

In the stress corrosion cracking studies, the method of Hyatt (3) was adopted, and double cantilever beam specimens were used. The crack growth rate (da/dt) measured in mm/hr was determined and plotted against the stress intensity factor (K_I). The curves for 7075-T6 alloy are shown in Figure 4. Here, the threshold values for K_I (K_{ISCC}) determined from the above plot indicate the SCC susceptibility of the material. K_{ISCC} is the value (the vertically straight portion of the plot) where the stress intensity becomes almost independent of crack growth rate. The higher the K_{ISCC} , the higher the resistance to SCC. In 100% humidity with chloride the K_{ISCC} value was significantly higher with the DNEM combination than with no inhibitor (cf. curve 3-3 with curve 2-2 in Figure 4). At a stress intensity factor of approximately 550 $KPa\sqrt{mm}$ DNEM retarded the crack growth rate by a factor of 8.

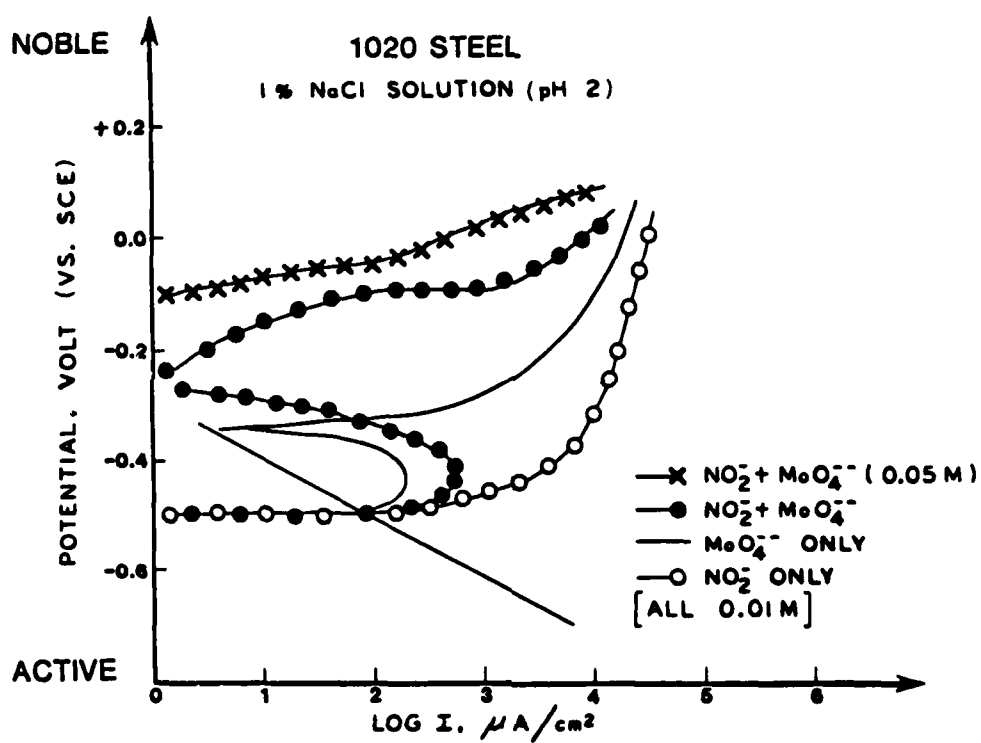
Figure 6. Polarization behavior of 1020 steel in the presence of corrosion inhibitors.

for various functional properties. The dichromate, nitrite and molybdate were studied for their passivating, oxygen-scavenging and chloride resistance properties. Electrochemical hydrogen permeation experiments were performed for hydrogen inhibition effect by dichromate and molybdate. It was found that during cathodic reactions, the entry of the hydrogen evolved into the metal can be delayed by these compounds by several factors. Potentiostatic anodic and cathodic polarization measurements were performed to determine the corrosion inhibition effect by these compounds according to the ASTM method G3-74. The details of this and other electrochemical techniques used in various corrosion studies have been better reported elsewhere (5). As an illustration, the effects of nitrite and molybdate compounds on the polarization behavior of 1020 steel in 1% NaCl (pH2) are shown in Figure 6. It was found that none of the inhibitors could show spontaneously passive behavior in the presence of chloride. The anodic polarization curves in each case were different but the cathodic curves were almost the same, thus only one was drawn in Figure 6. Among the inhibitors only the molybdate compound demonstrated some active to passive transition whereas the others continued to remain active even at higher potentials (in the noble direction). However, the combination of nitrite and molybdate showed a significant passive range (— curve). At a higher concentration (0.05M compared to 0.01M) of the inhibitors, the 1020 steel was spontaneously passive (-x-x- curve) as the corrosion potential shifted to very noble values. Thus a mixture of nitrite and molybdate was complementary in properties in aqueous medium. The additions of dichromate and borate to this mixture were not synergistic in action. In an organic medium, the identity of each compound was retained, as in the DNBM formulation in mineral spirits, and made available when cracking inhibition was needed. Mechanistically in the mixture of DNBM, dichromate served as a good passivator, molybdate as a pitting inhibitor (resistance to chloride attack), nitrite as an oxygen scavenger and as a passivity restorer, and borate as a pH modifier. Additionally, dichromate and molybdate-inhibited hydrogen absorption by the metal.

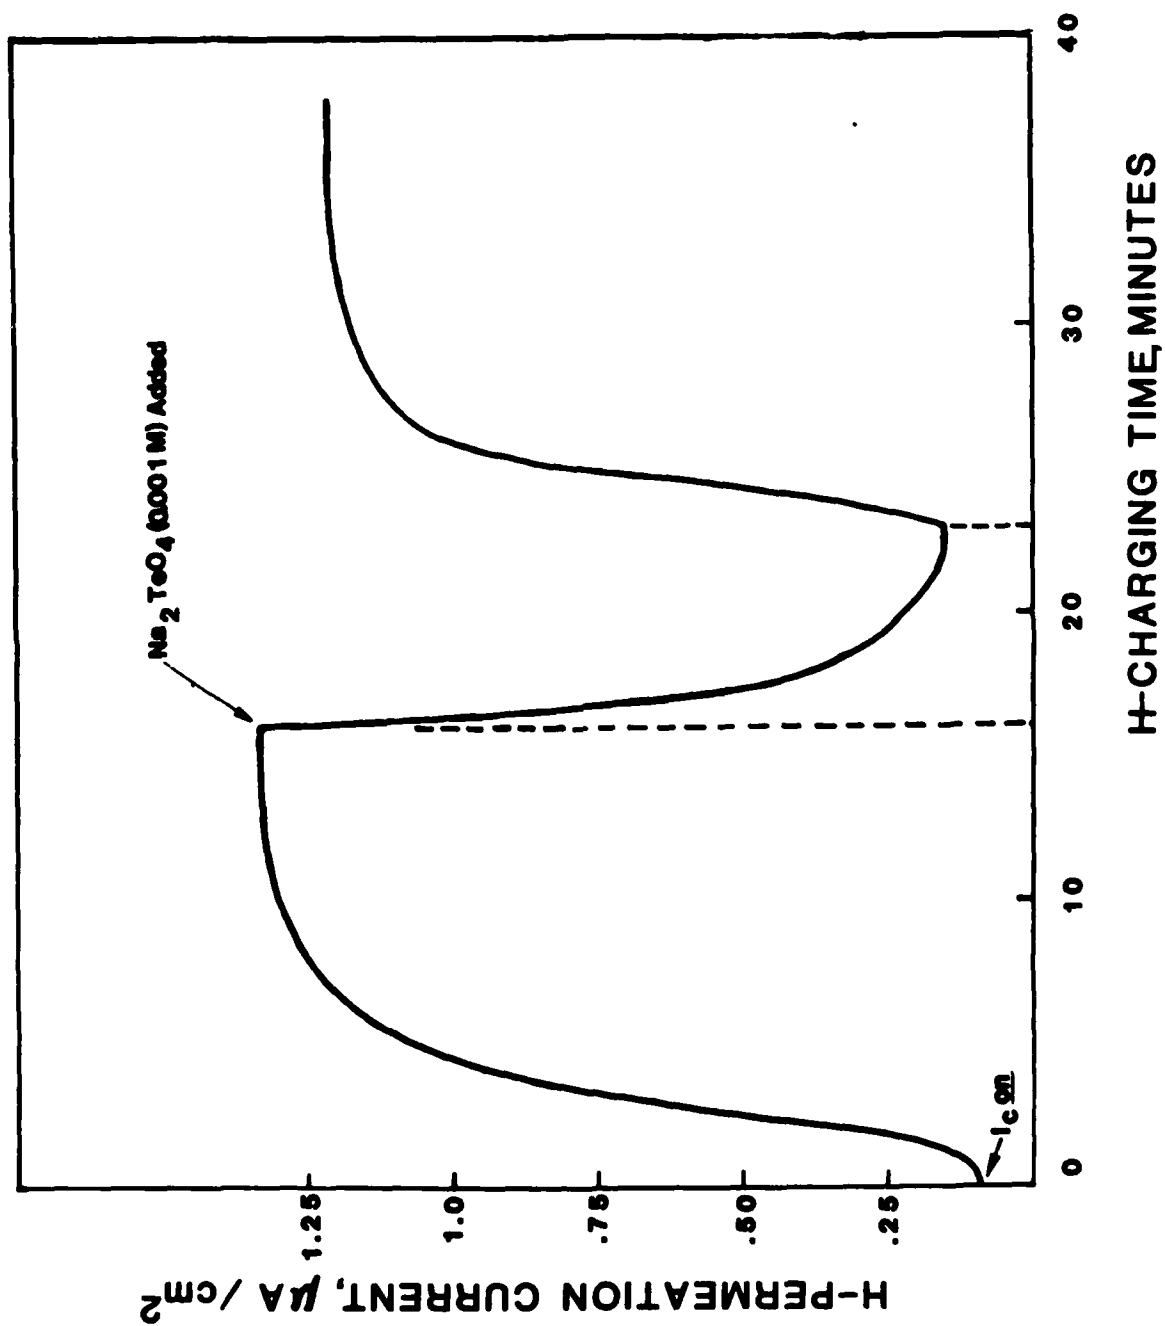
Figure 7. Effect of sodium tellurate on hydrogen permeation transient of Armco iron in 0.2M NaOH + 0.2M NaCN.

This method has been used to study the effect of inhibitors on the hydrogen diffusion through metals as shown in Figure 7. As cathodic charging proceeds, hydrogen is produced, permeates through the specimen, and builds up to a maximum concentration as shown by the steady state oxidation current. At this point, sodium tellurate is added to the charging solution. There is a dramatic drop in hydrogen permeation current due to the reduction of the tellurate, rather than of the hydrogen ion. Subsequently, the permeation current slowly increases, but does not reach the original value due to the slight barrier effect of tellurium which has been deposited. Thus it has been shown that the tellurate ion, an electron acceptor, can delay the production of hydrogen. If sodium tellurate is added to a plating bath, this may delay the production of hydrogen, thus reducing the total hydrogen pickup during conventional plating. Used as an inhibitor, it could also reduce the hydrogen uptake during the corrosion process.

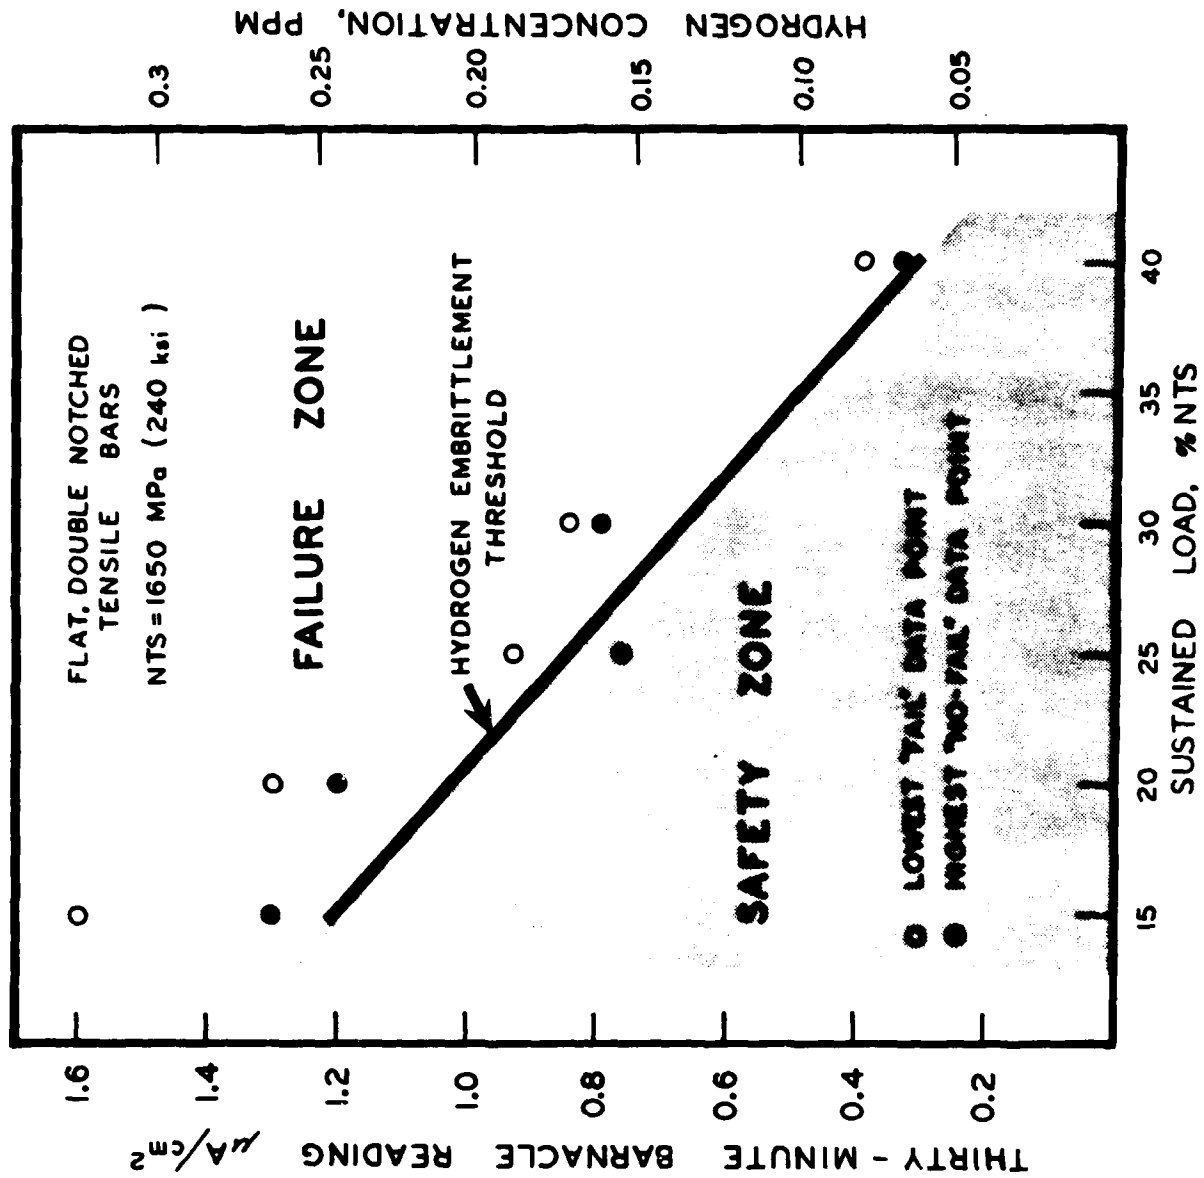
Figure 8. Hydrogen embrittlement threshold plot for 4340 steel.

remains. If a wide range of stresses is used along with different hydrogen concentrations, a complete indexing of the degree of embrittlement of a susceptible alloy can be obtained. Figure 8 shows the threshold curve indicating safe and unsafe hydrogen concentrations for a cathodically charged unplated 4340 steel. Comparing this with the results shown with a cadmium plated steel in Table 1, it can be seen that an indexing curve for plated material would shift to a more dangerous position.

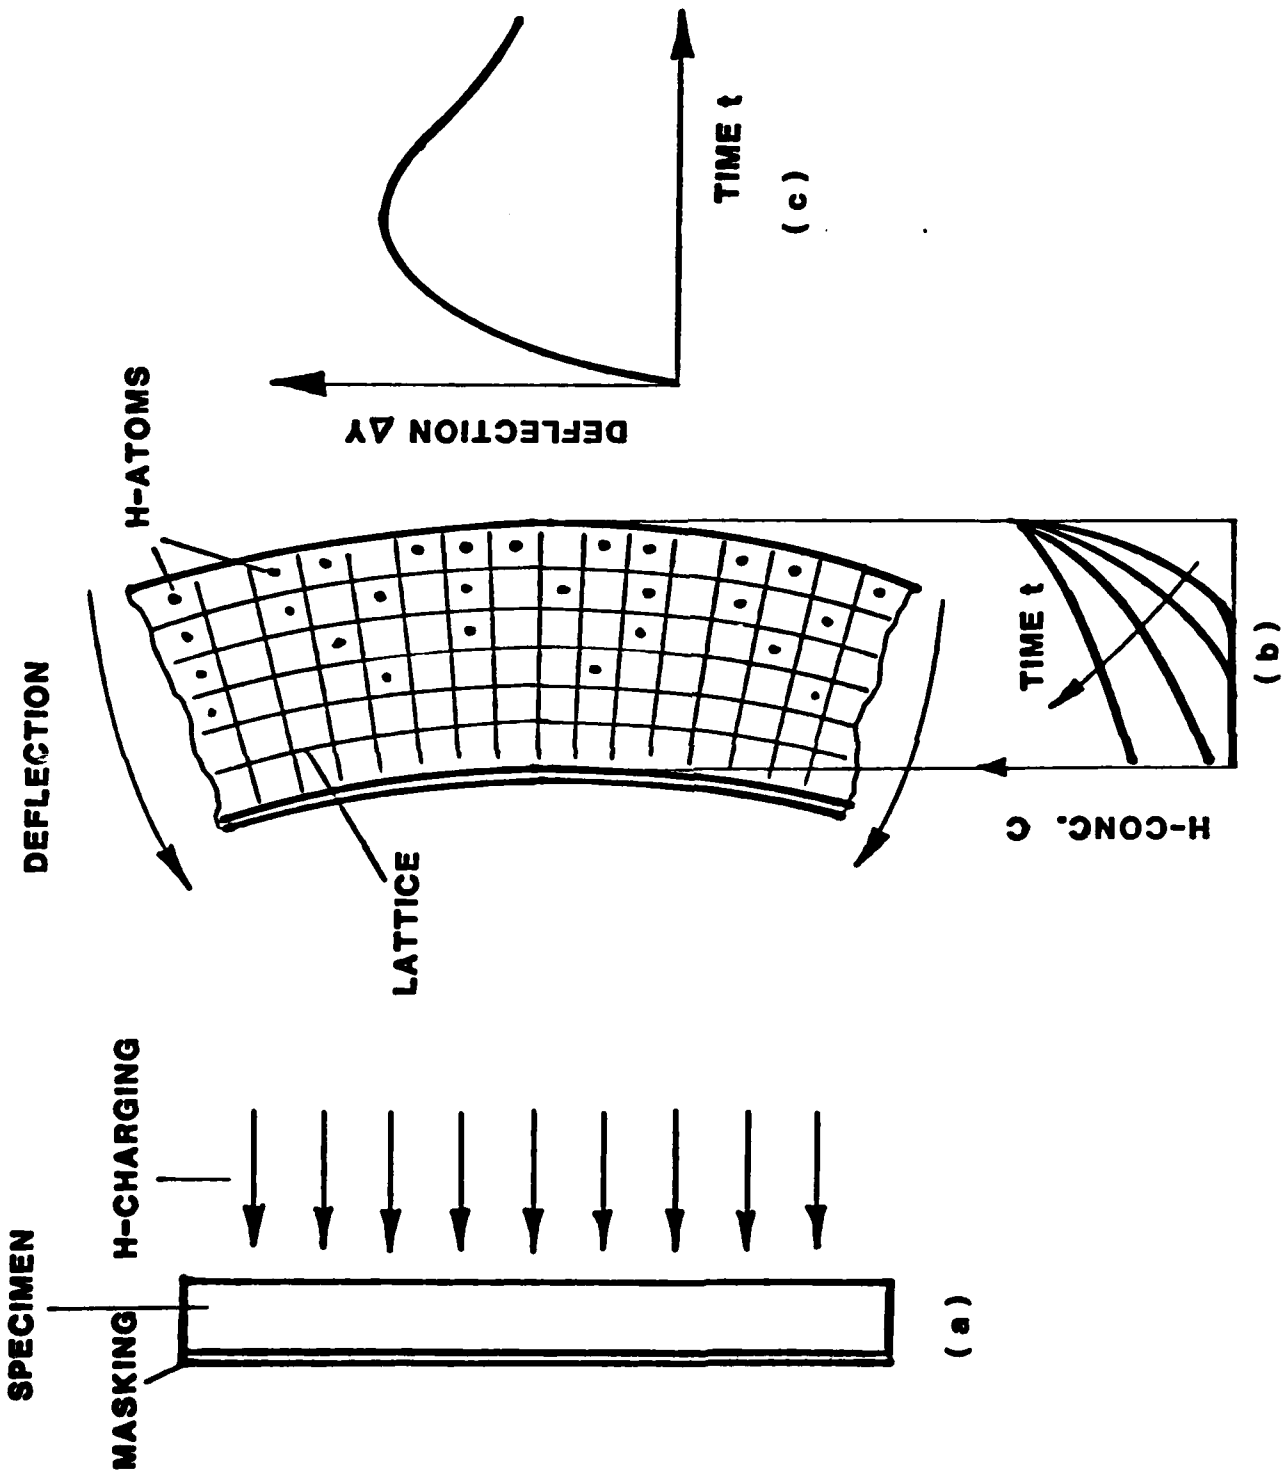
Figure 9. Schematic diagrams of hydrogen induced deformation (bending) showing a specimen (a), bending due to lattice expansion (b) and bending vs time relationship (c).

A somewhat different approach to the hydrogen embrittlement problem is from the viewpoint of its effect on the metal lattice (8, 9). Interstitially dissolved hydrogen in the metal lattice causes local disorders of an elastic nature. Accumulation of lattice disorders in one region of the specimen volume creates stresses which may result in a macroscopic deformation of the specimen and permanent damage to the material in high stress areas. The accumulation of local disorders can be created by electrochemical charging. If, for example, a specimen in the shape of a bar, Figure 9a, is cathodically charged on one side, it will bend, as shown schematically in Figure 9b. The degree of this bending depends upon the hydrogen concentration gradient through the thickness of the specimen. Since the hydrogen concentration profile shown in Figure 9b changes with time, so does the bending. This bending goes through a maximum, Figure 9c, which is characteristic of the material, and which can be used for calculating the diffusion coefficient and the hydrogen concentration.

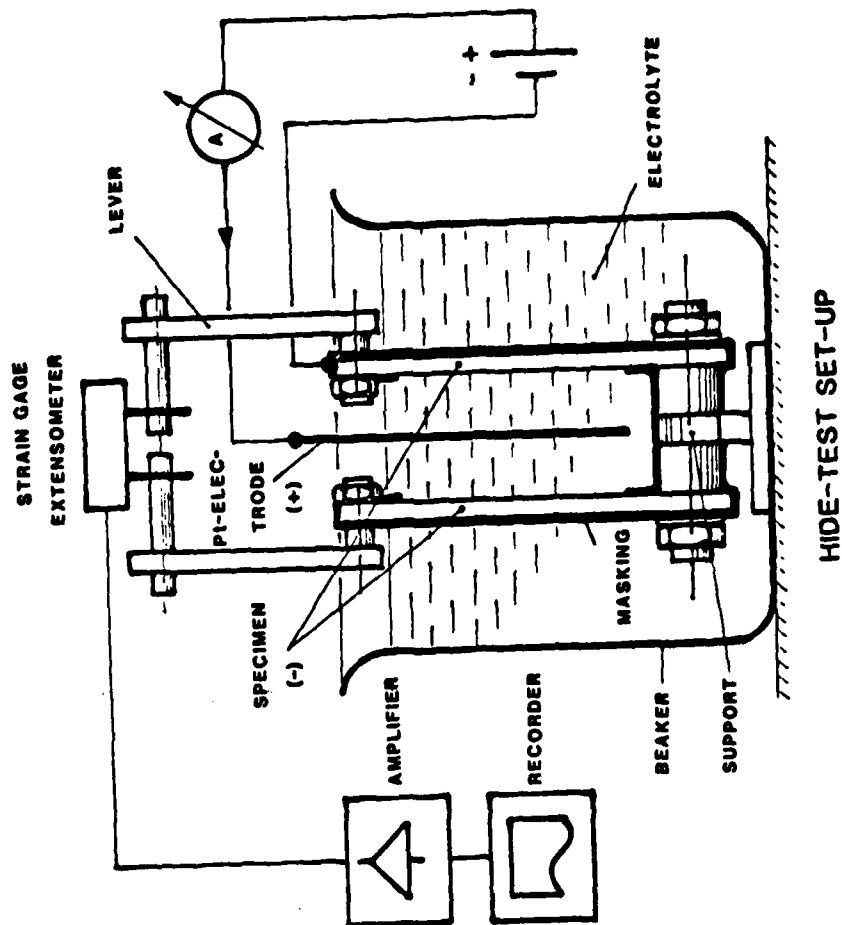
Figure 10. Schematic of hydrogen induced deformation experiment.

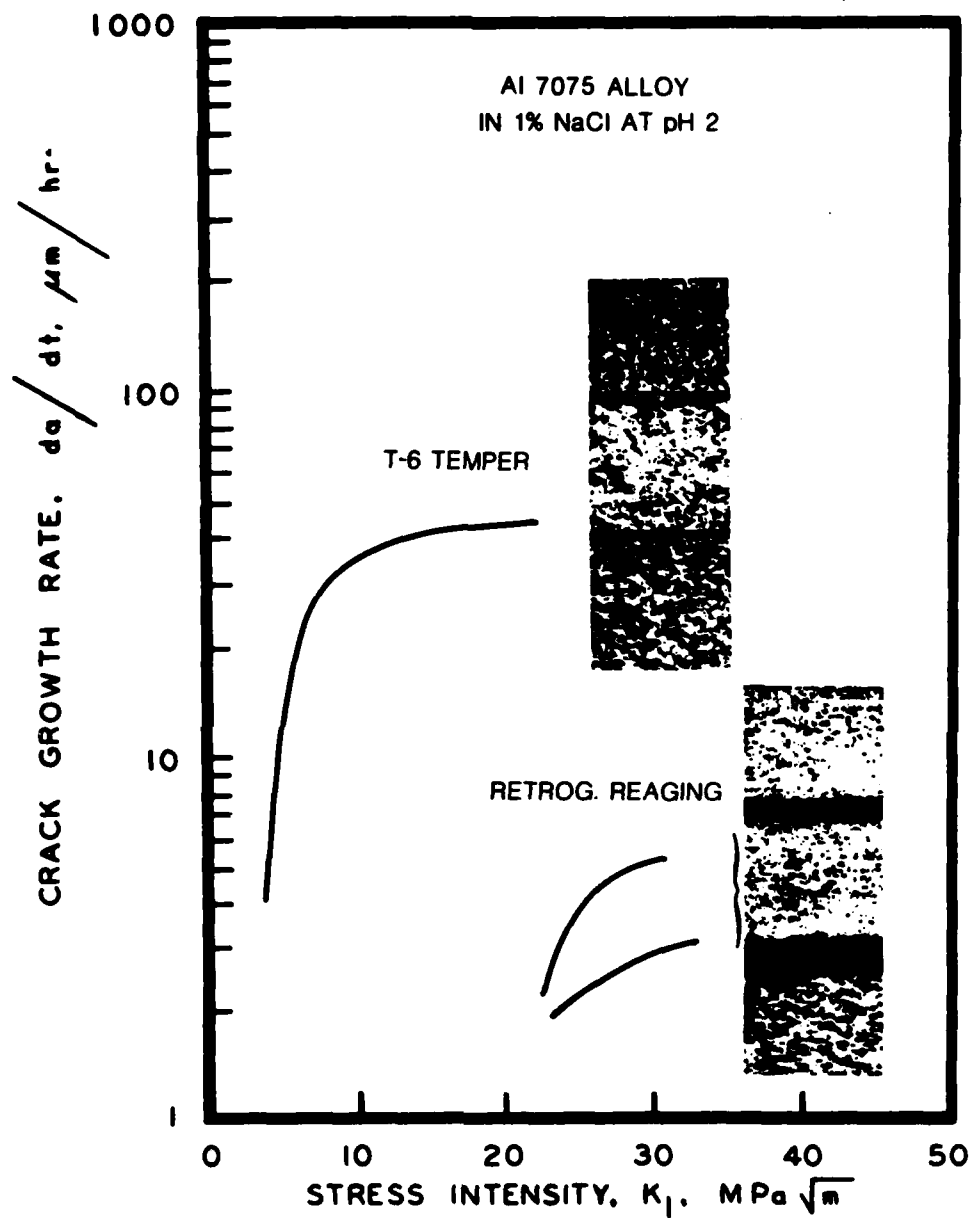
Figure 12. Effect of heat treatment on exfoliation and stress corrosion cracking behavior of 7075-T6 alloy.

Recently, it has been demonstrated (12) that a pre-aging treatment for 7075 aluminum alloy improves its resistance to SCC without sacrificing the maximum strength of the T6 temper. This process which is called retrogression and re-aging (RRA) is a two-step treatment after the alloy has been heat treated to the T6 condition. First, the material (7075-T6) is "retrogressed" at a temperature between 200-260°C for a short time, water quenched, then re-aged at the original aging temperature of 120°C. The details of this procedure are described elsewhere (12, 13). To illustrate the corrosion behavior of such RRA-treated one-inch thick 7075-T6 plate, both SCC (ASTM Standard G38) and exfoliation corrosion (ASTM Standard G34) susceptibility tests were carried out. The study of the crack growth rate (da/dt) with decreasing stress intensities (K_I) in a 3.5% NaCl solution at pH2 was also performed. It was found that RRA-treated material had almost the same behavior as T73 tempered material. Figure 12 shows the results of a da/dt vs K_I plot for SCC behavior of both the T6 and RRA treated specimens. The SCC threshold, $K_{I_{SCC}}$, for RRA-treated material was much higher than for T6 alone. The photographs adjacent to each curve (treatment) in Figure 12 show the exfoliation corrosion behavior. The RRA specimen shows only slight corrosion, an improvement from EB to EA according to ASTM Standard G34, indicating a significant resistance to intergranular corrosion. The hardness of the 7075-T6 alloy was only slightly sacrificed, i.e. from 94-95 to 88-89 R_B , after the RRA treatment. The future in this area is quite promising.
